INDOOR AIR QUALITY ASSESSMENT

Carbon Monoxide/Soot Investigation

**Augustine Belmonte Middle School
25 Dow Street
Saugus, Massachusetts**

Prepared by:
Massachusetts Department of Public Health
Bureau of Environmental Health Assessment
March, 2002

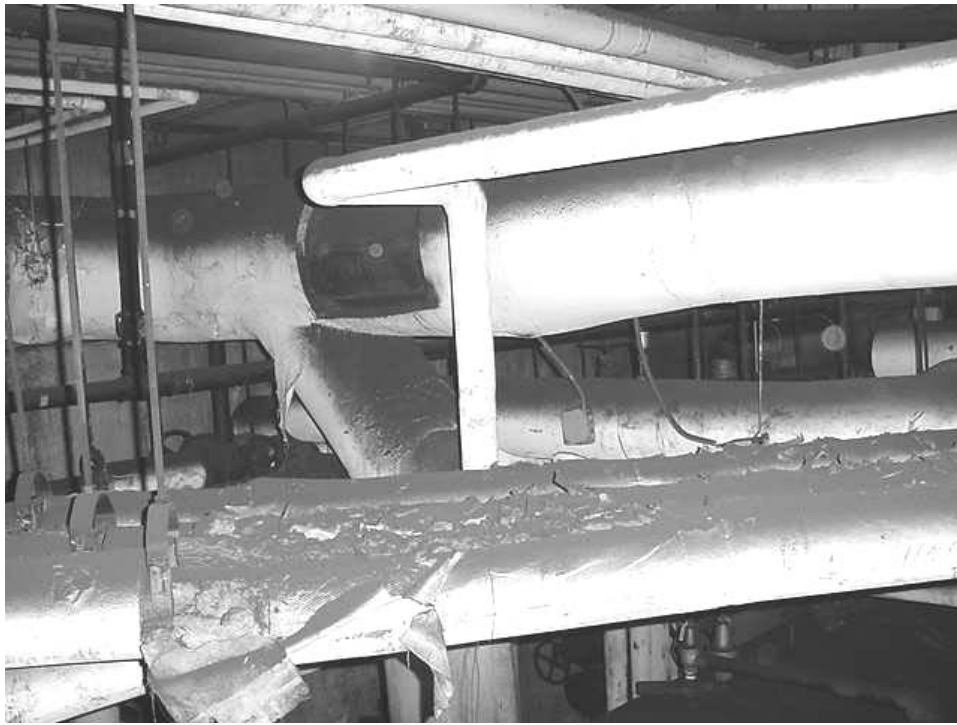
Picture 1

simultaneously was the most likely source of soot backed up through cracks, crevices and other breaches of the chimney/flue. The deterioration of the chimney liner in combination with the undersized chimney flue, insufficient make up air and certain wind and weather conditions, overwhelms the ability of the chimney to exhaust products of combustion from the boiler room causing a back up of soot (see Picture 1) and other combustion products (Saugus, 2002).

Soot Accumulation on Surfaces in Boiler Room

1. Continue with plans to conduct structural repairs/replacement of flue (outlined in the Emergency Procurement Waiver) to prevent the possibility of future exposure to combustion products.

2. Continue with plans to hire a professional cleaning/restoration firm to conduct a thorough cleaning of areas impacted by boiler blow back.
3. Keep boiler room and loading dock doors closed at all times. Replace loading dock doors with tight-fitting doors that fit completely flush with threshold. Seal doors on all sides with foam tape, and/or weather-stripping.

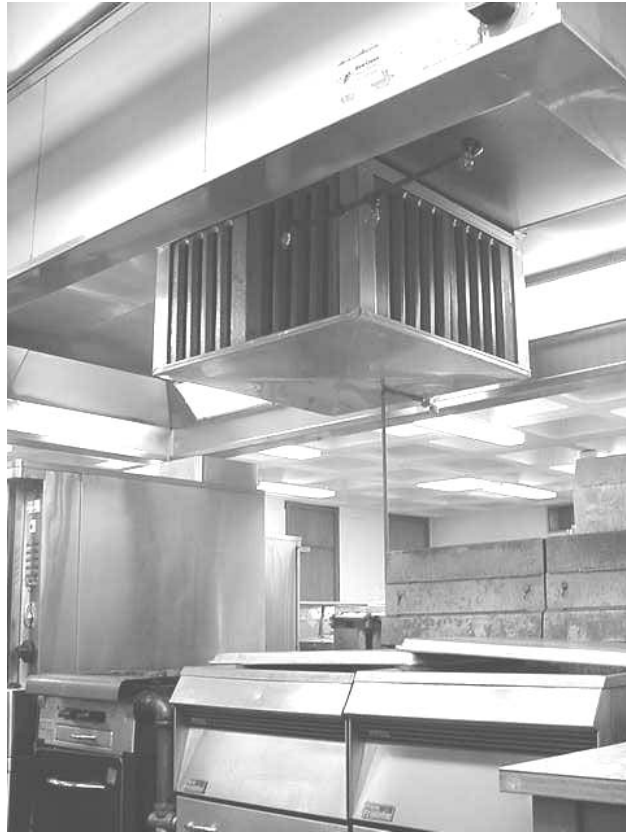
Picture 2

A second potential CO source was identified in the kitchen area. Located in the center of the kitchen are a number of gas fired kitchen appliances (e.g., ovens, stoves, fryolators) installed beneath a vent hood (see Picture 2). School/town officials stated that at the time of the CO incident the vent hood was not operational. BEHA staff confirmed that this vent has since been repaired and was operating during the assessment. However, the vent hood was intended to provide exhaust ventilation for kitchen equipment that was present when the kitchen was first opened. Over the years more equipment has been added without the modification/adjustment of exhaust capabilities.

Gas Powered Appliances under Vent Hood in Kitchen

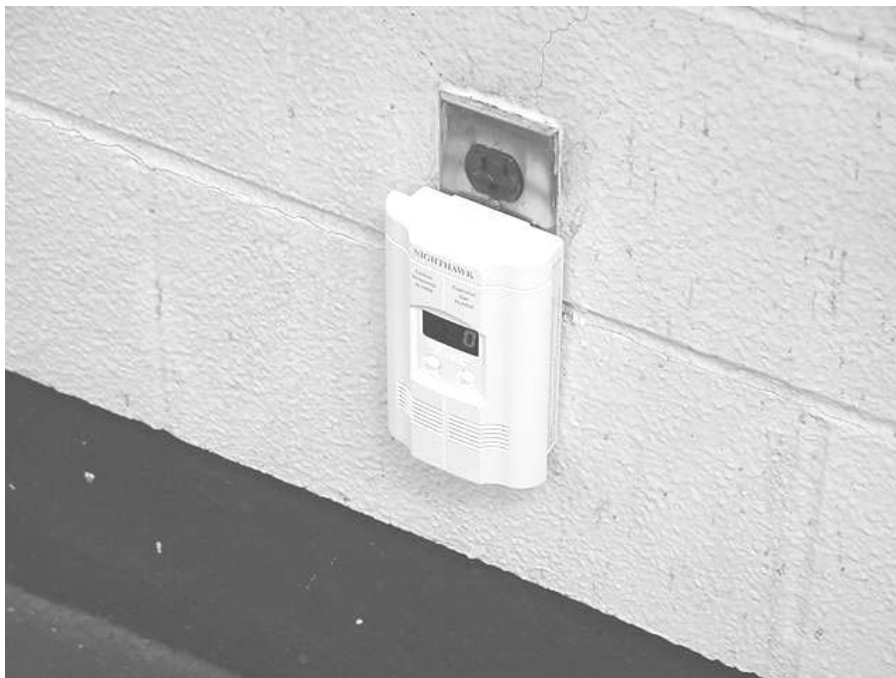
Picture 3

Wall-Mounted CO Detector

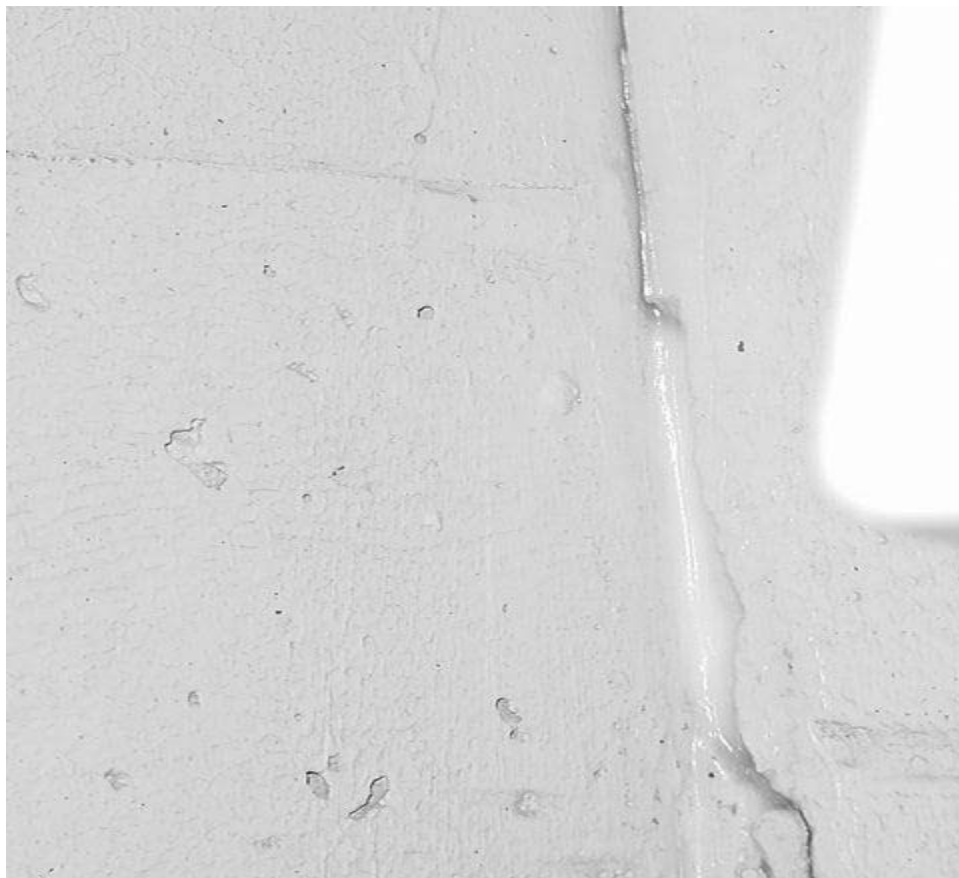
Picture 4

Prior to the BEHA assessment, school and town officials had reportedly already taken a number of remedial measures. To avoid overloading of combustion products into the chimney flue an automatic lock-out control has been installed on the boiler system allowing only one boiler to run at a time. Oil burners were also serviced to ensure proper mixing of air/fuel. Testing and operation of the emergency generator during school hours has been discontinued. Some gas-fired kitchen equipment is now discontinued and a new wall-mounted CO monitor was installed in the kitchen (see Picture 3). Finally, floor penetrations, and cracks and crevices in the chimney and boiler room, have been sealed to prevent the migration of combustion products into occupied areas (see Picture 4). Daily

Sealed Wall Crack in Chimney

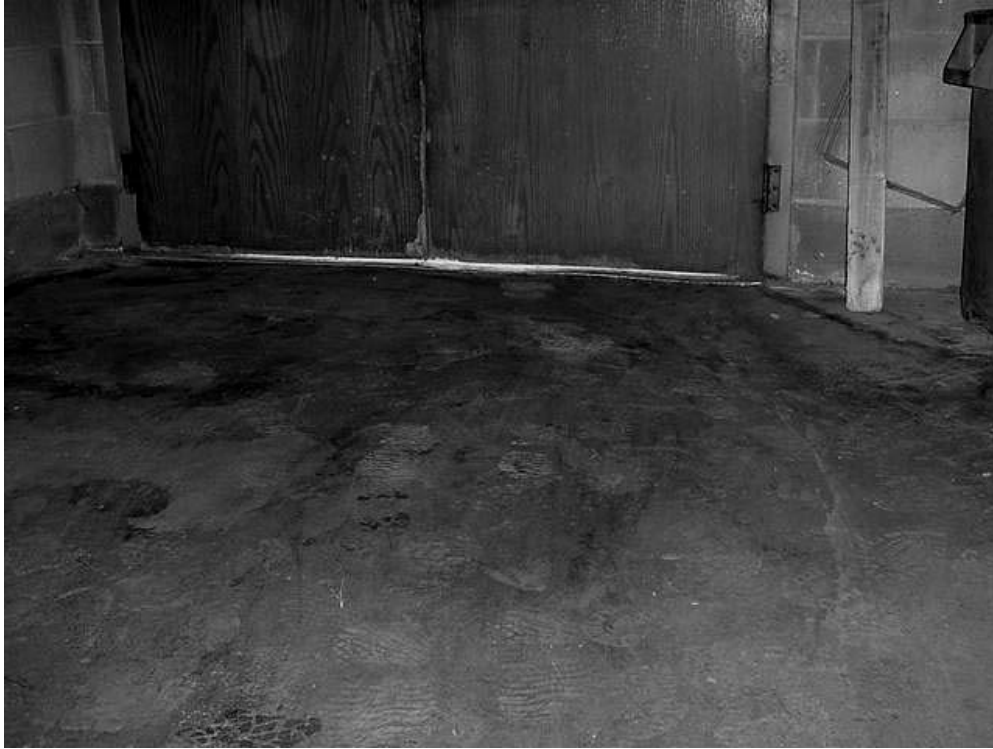
Picture 5

room into occupied areas on both the first and second floors. Several pathways were observed in the vestibule directly adjacent to the boiler room. The boiler room doors are not airtight, which allows dirt, dust and particulates to migrate into adjacent areas. The vestibule also serves as the loading dock for the cafeteria. Significant spaces were noted beneath the loading dock doors from which drafts were detected and light could be seen penetrating (see Picture 5). An abandoned electrical panel and a number of utility holes in the restroom ceiling (see Pictures 6 & 7) next to the loading dock were also found, which may also serve as potential pathways.

**Spaces around Loading Dock Door Directly Adjacent to Boiler Room
Note Light Penetration**

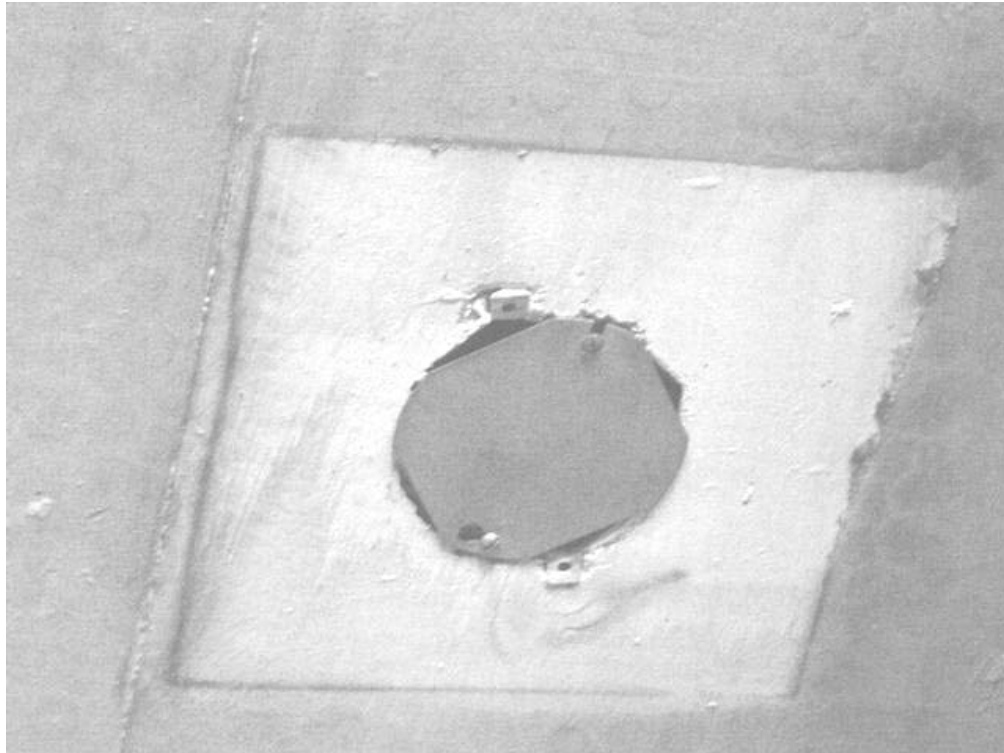
Picture 6

**Abandoned Light Fixture in Restroom Ceiling Adjacent to Boiler Room,
Note Spaces around Metal Plate**

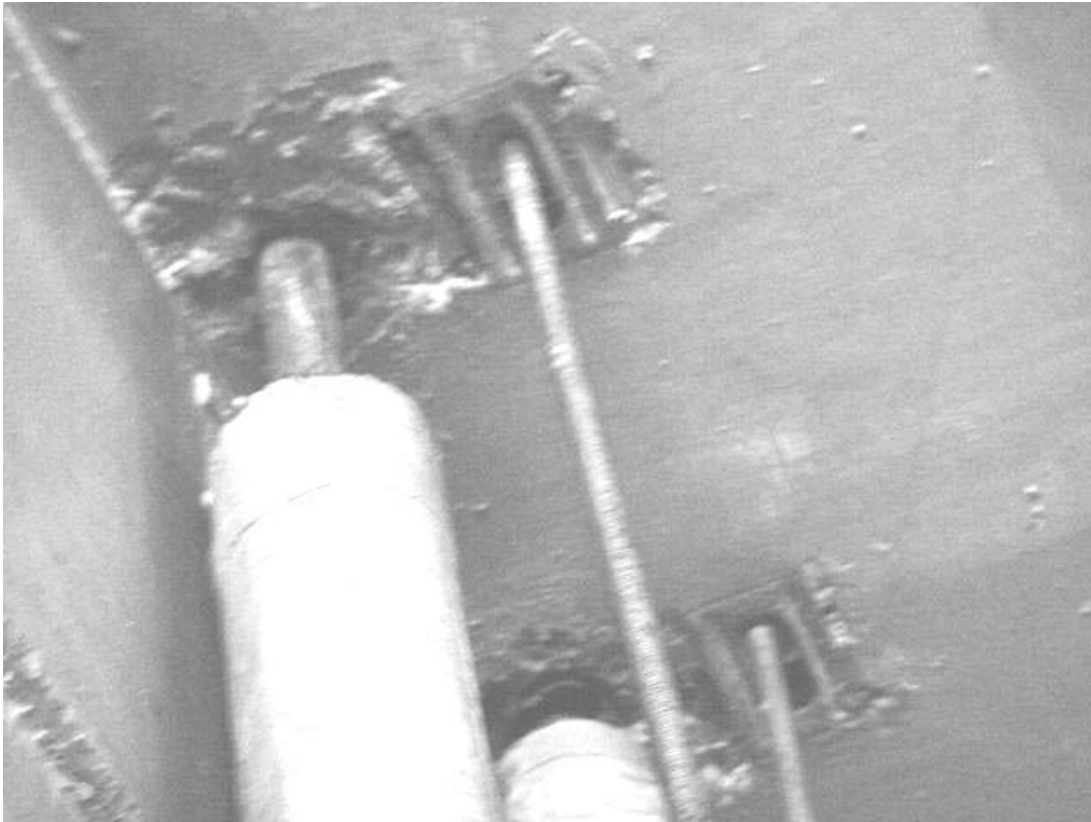
Picture 7

Utility Holes in Restroom Ceiling Adjacent to Boiler Room

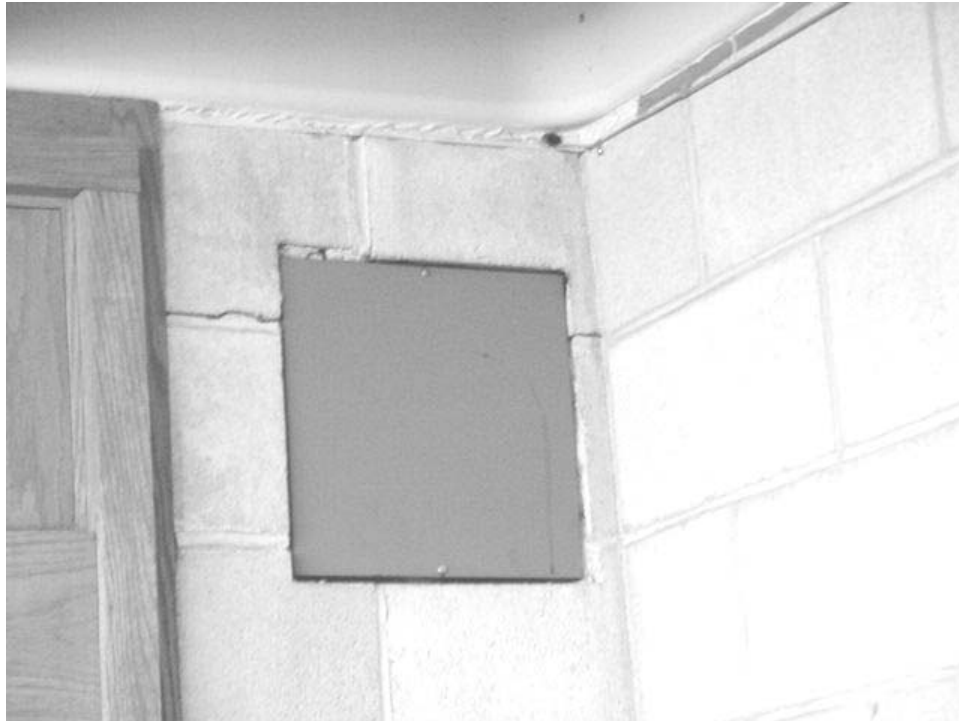
Picture 8

BEHA staff examined the chimney traversing the kitchen area and observed a metal panel with spaces around it that was not sealed (see Picture 8). Other potential pathways were identified in the slop room off the kitchen area, including the slop sink drain (see Picture 9) and the abandoned chute for the incinerator.

Spaces around Access Panel in Kitchen Storeroom

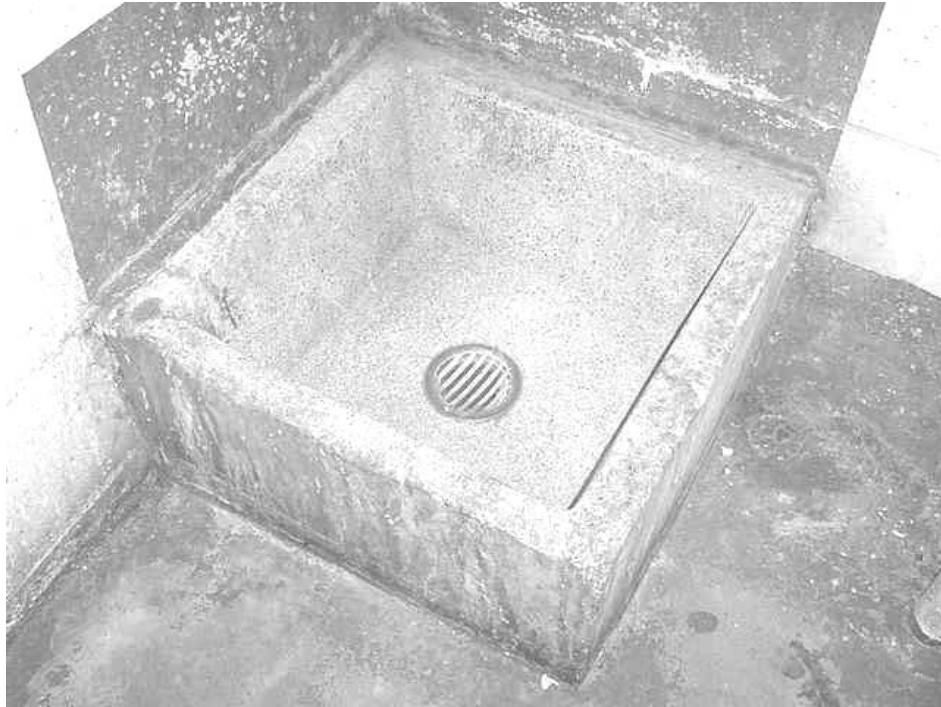
Picture 9

Drain in Slop Room off Kitchen

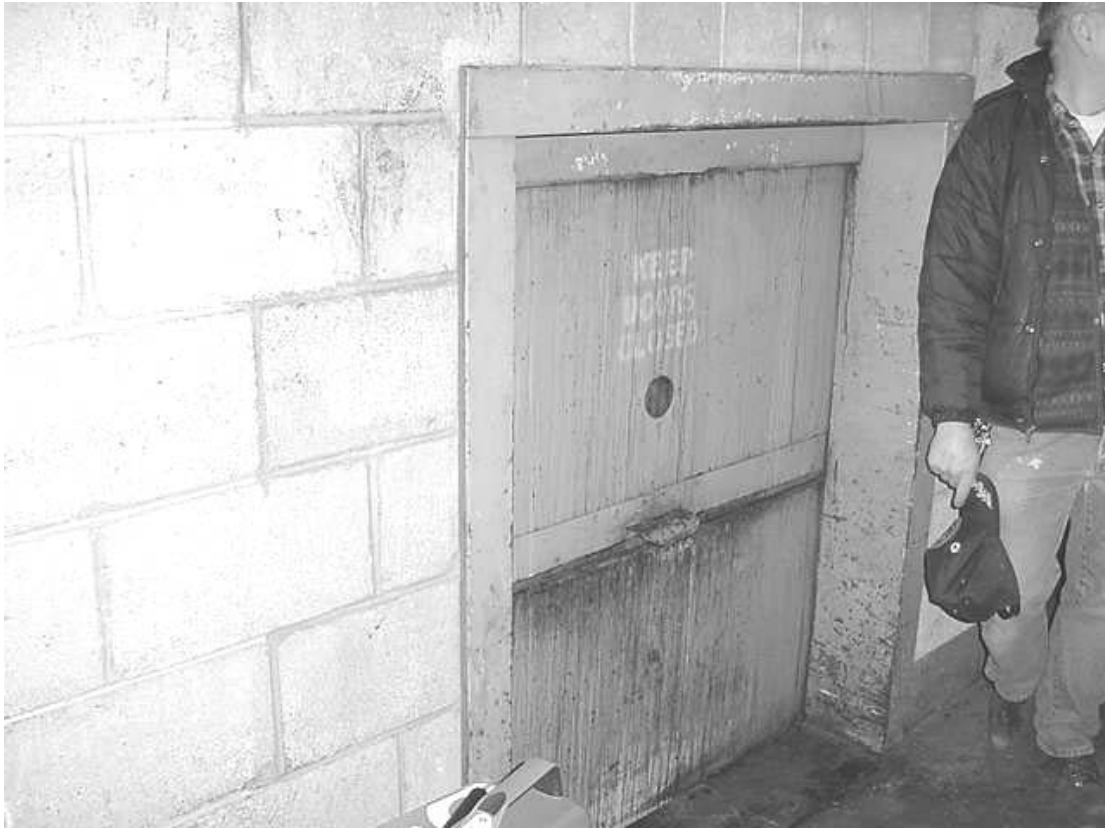
Picture 10

The most obvious pathway in which combustion products can travel from the boiler room into the kitchen area is via a dumbwaiter located in the loading dock area (see Picture 10). Products of combustion can enter the vestibule around the boiler room door. The loading dock becomes pressurized by drafts entering through spaces around the loading dock doors. When this area becomes pressurized, it can force combustion products through any available pathways that may be present (e.g., wall cracks, abandoned ductwork, utility holes). Further, once combustion products/odors are in the loading dock area they can be distributed to the second floor/kitchen area via the dumbwaiter shaft. The piston effect, created by dumbwaiter movement, can temporarily place the loading dock under negative pressure as the dumbwaiter moves upwards, subsequently enhancing the distribution of combustion products into occupied areas.

Dumbwaiter Located in Loading Dock Area Adjacent to Boiler Room

5. Ensure vehicle engines are off during loading/unloading operations to prevent entrainment of vehicle exhaust.
6. Consider discontinuing use of dumbwaiter until boiler room improvements are made and boiler room and loading dock doors are replaced/sealed.
7. Ensure all utility holes and wall cracks are properly sealed to eliminate pollutant paths of migration. Consider contacting a plumber to inspect the slop room drain for integrity.
8. Consider removing incinerator and completely seal abandoned chute in slop room. If not removed, ensure abandoned chute is sealed airtight to prevent the migration of boiler room pollutants/odors into slop room.
9. Continue with plans to improve exhaust capabilities for kitchen equipment. Consider contacting a heating ventilation and air conditioning (HVAC) engineering firm specializing in proper food service/restaurant ventilation systems.
